COMMONWEALTH OF KENTUCKY
BEFORE THE PUBLIC SERVICE COMMISSION

HENDERSON-UNION RURAL ELECTRIC)	
COOPERATIVE CORPORATION, INC.)	
)	
_____)	CASE NO. 90-260
)	
ALLEGED FAILURE TO COMPLY WITH COMMISSION)	
REGULATIONS)

ORDER TO SHOW CAUSE

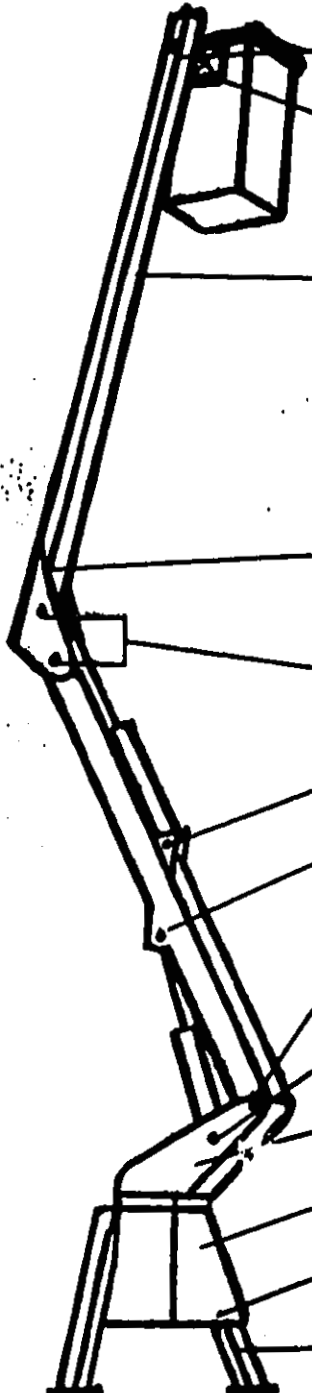
BUCKET TEST REPORT

Customer: Henderson - Union RECC Date: 9-13-89 Report No.: 2
Model: 805-45 Truck No.: 35
Serial No.: 87-25292 Technician: Herman LaDuke

PLATFORM PIN Could not be checked

PLATFORM BRACKET OK

BOOM EXTERIOR CONDITION OK

ELECTRICAL HAZARD DECALS OK
